Re: Comments on Bosma Lagoon 10 Basis of Design Report  
Administrative Order on Consent ("Consent Order")  
Docket No. SDWA-10-2013-0080  
Yakima Valley Dairies, Washington

H&S Bosma Dairy Consolidated Lagoon No. 10 Basis of Design Report 100% Design Submittal  
(June 24, 2019)

**Figure 3**  
**H&S Bosma Dairy Consolidated Lagoon No. 10 Subsurface Soil Characteristics Cross Section 10A-10A'**

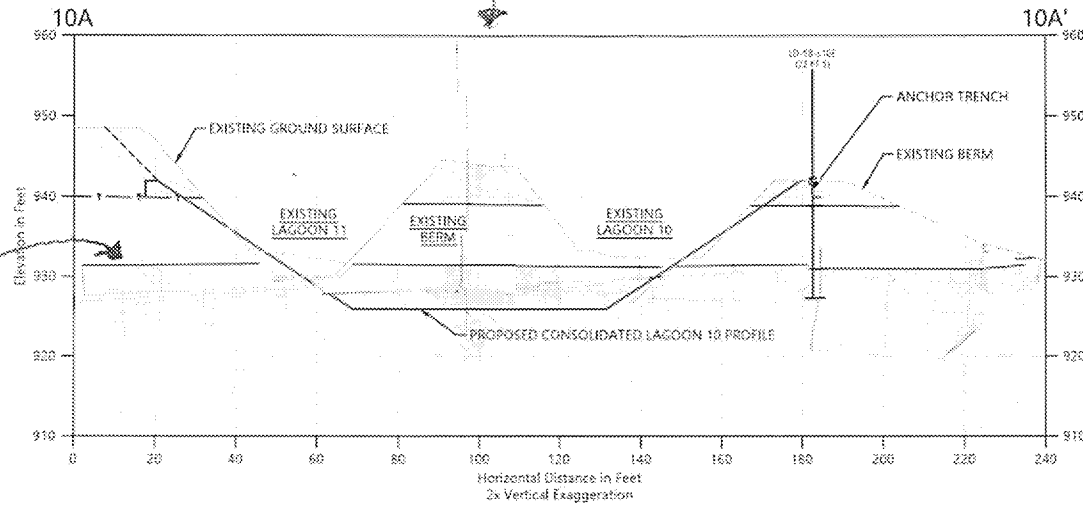
12. Consideration of the test pit data indicates that Figure 3 (H&S Bosma Dairy Consolidated Lagoon No. 10 Subsurface Soil Characteristics Cross Section 10A-10A') in the approved Report is inaccurate. Provide a revised Figure 3 (lagoon cross section) that includes consideration of the test pit data. The test pit sample data indicate that the bottoms of Lagoon 10 and/or Lagoon 11 intersect the lower "Gravelly Silty Sand (Fill)" soil layer shown in Figure 3 in the Report. Delete the information from LD-SB-L105S, which is located 138 feet south of the cross section and is not consistent with the data that is available on the cross section.

Delete south boring (not on transect)

Raise this line to intersect bottom of Lagoon 11 (as shown)

Pursuant to Paragraph 14 of the Consent Order, the Respondents must address these comments and re-submit this document no later than August 16, 2019. Revise Figure 3 as indicated in the enclosed figure which EPA has modified.
